## **Revised Arborist Report**

Parkside Trails  
Cupertino, CA

April 2014

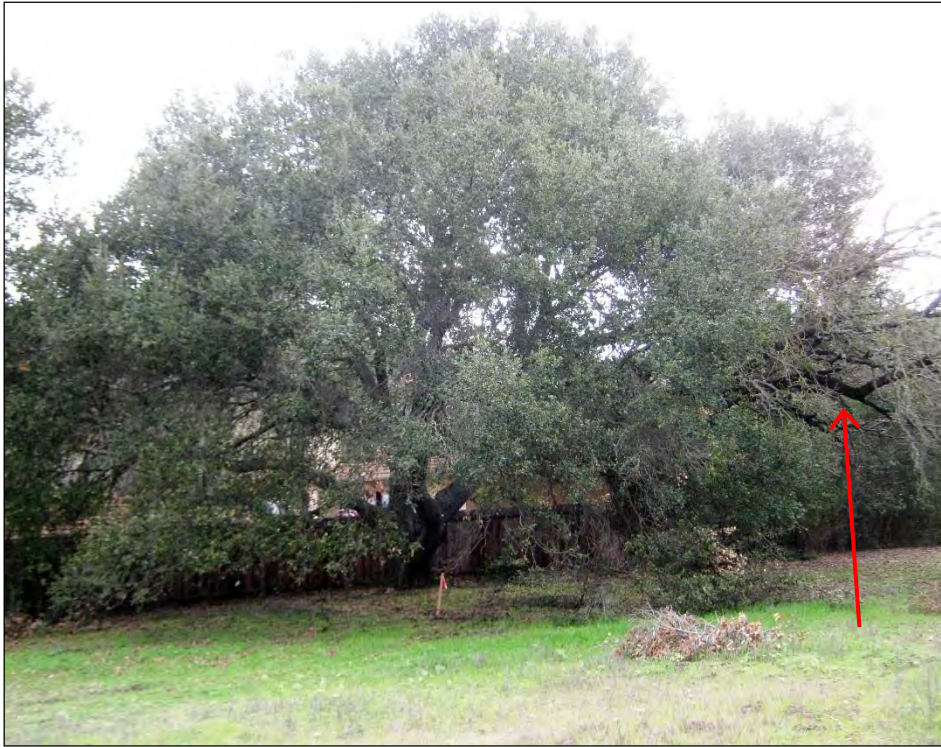
**Photo 1:** Coast live oak #41 (L) was the dominant tree. Valley oak #42 (R, arrow) was suppressed beneath the canopy of #41, producing a tree that leaned west to horizontal.

Valley oak was represented by eleven (11) trees, or 3% of the population. One of the valley oaks was off-site (#3) and mature in form and development, at 24" in diameter. On-site valley oaks were young to semi-mature (7" to 18" in diameter) and intermixed with coast live oaks. Six (6) were in good condition and three (3) were in fair. None of the valley oaks were in poor condition. Just like the coast live oaks, valley oaks in good condition were upright and open grown, and those in fair condition, with suppressed forms (photo 1, previous page).

TREE	SPECIES	SIZE	PROTECTED?	CONDITION	SUITABILITY	COMMENTS
No.		DIAMETER (in inches)		1=POOR 5=EXCELLENT	FOR PRESERVATION	
42	Valley oak	18	Yes	3	Moderate	Codominant trunks at 7'; suppressed; crown bowed W. to horizontal.
43	Coast live oak	14	Yes	5	High	High crown; upright form.
44	Coast live oak	11	Yes	5	High	Crowded; high crown; upright form.
45	Coast live oak	10	Yes	5	High	Crowded; one sided W.; upright form.
46	Coast live oak	8	No	5	High	Good young tree; growing against fence.
47	Coast live oak	6,4,2	No	5	High	Multiple attachments at base; good young tree.
48	Coast live oak	6	No	5	High	Good young tree.
49	Coast live oak	12,11,5	Yes	4	Moderate	Multiple attachments at base; thin canopy; twig dieback.
50	Coast live oak	6	No	4	High	Upright form; thin canopy.
51	Coast live oak	19,12	Yes	3	Moderate	Multiple attachments at 5'; one sided W.; twig dieback.
52	Coast live oak	8	No	4	Moderate	Upright form; slight crook at 6'.

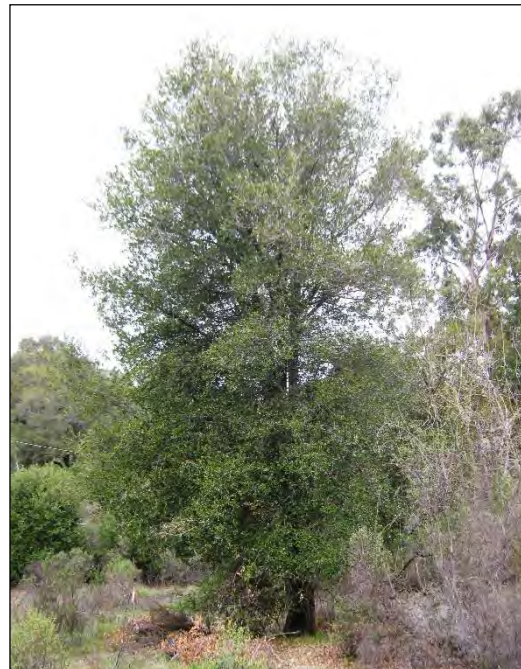
**Photo 2:** Open-grown coast live oak #166 was semi-mature, at 15" in diameter. The tree was in good condition and was typical of the other open-grown oaks at the site.

164	Coast live oak	6,3,3	No	4	High	Multiple attachments at base; branches to ground; crooks.
165	Calif. black walnut	11,7,4	No	2	Low	Lost top; trunk decay; poor form.
166	Coast live oak	15	Yes	4	High	Codominant trunks at 5'; seam in attachment.
167	Coast live oak	6,4	No	4	High	Codominant trunks at base; narrow attachment.
168	Calif. black walnut	13,12,11,9	No	2	Low	Multiple attachments at 4'; trunk decay; poor form.
169	Coast live oak	7	No	4	High	Codominant trunks at 4'; one sided NW.
170	Coast live oak	11	Yes	5	High	Upright form; slight sweep in trunk.
171	Coast live oak	7	No	4	High	Trunk sweeps S. to 5'; one sided S.
172	Coast live oak	11,6	Yes	5	High	Codominant trunks at 1'; good form.
173	Calif. black walnut	11,9,6,6	No	3	Low	Multiple attachments at 4'; trunk decay.
174	Calif. black walnut	10,10,8,8,7	No	3	Low	Multiple attachments at base; several stems decayed.
175	Coast live oak	12,9,9,7,6,5	Yes	5	High	Street tree; multiple attachments at base; good form.
