# Project Update: Creek restoration, startup & earthwork

## Stevens Creek Corridor Creek Restoration Project

### THE CONSTRUCTION STARTS

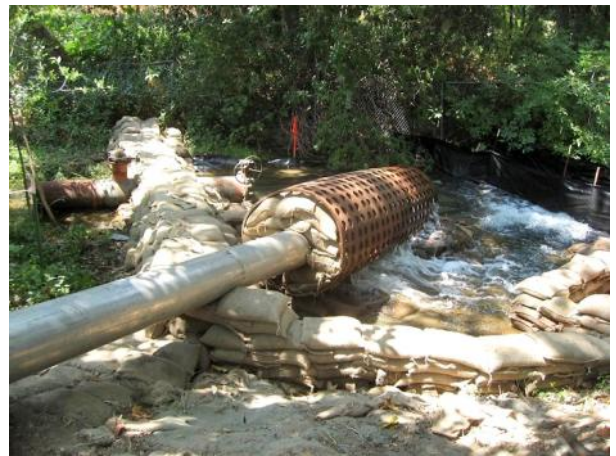
Creek water was pumped into a pipeline and returned to the channel near the south end of the golf course. At the downstream end of the diversion system, a specialized outfall structure served to dissipate energy from the flows exiting the pipeline and prevent scour as the water was returned to the natural channel. During this time, native plants were salvaged from the areas of the channel about to be modified by construction.

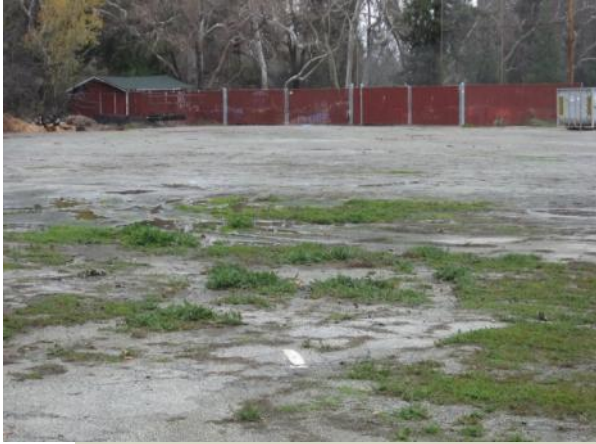
*By late 2007, paving in the Blackberry Farm parking lot had reached the end of its service life. The surface had extensive potholes and vegetation was growing through*

*In June 2008 construction started. An initial task was asphalt removal. The parking lot had to be cleared of asphalt early on since part of it was to become the new creek channel*

Construction of Stevens Creek Corridor Phase 1A, Creek Restoration commenced in June 2008. One of the first tasks was to clear the site and begin demolition. The western portion of the old parking lot had to be removed to make way for the new creek channel alignment. The creek restoration contractor, Ferma Corporation, started work with the removal of the parking lot asphalt in June.

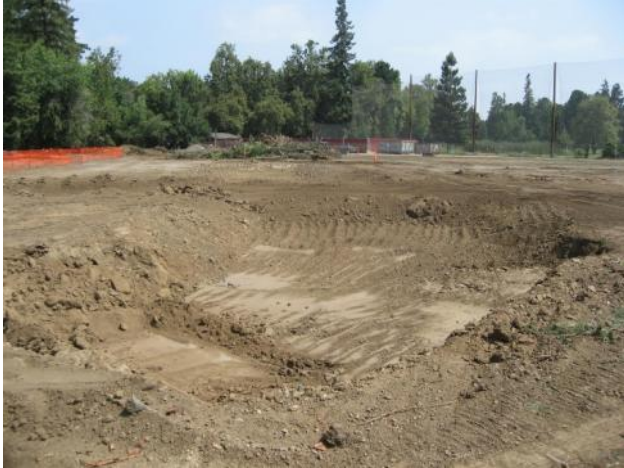
*In mid July, the creation of the new channel was started in the parking lot area*

*An excavator began the first step of digging the new channel*

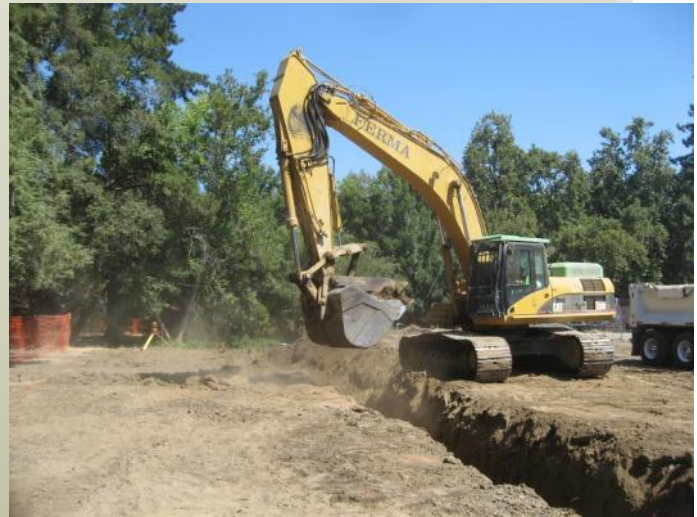
*Excavation proceeded efficiently and on schedule*

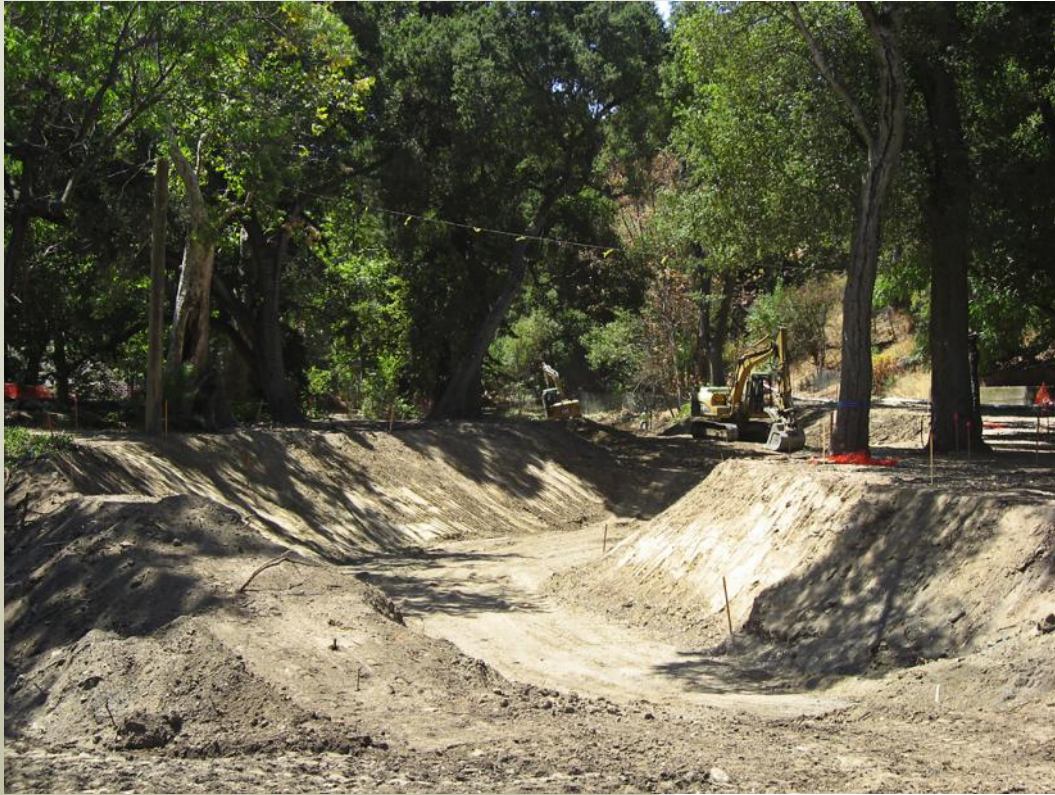
*The creek channel was excavated, with an alignment tailored to the locations of trees. The entire team worked long hours during this time and the work progressed well*

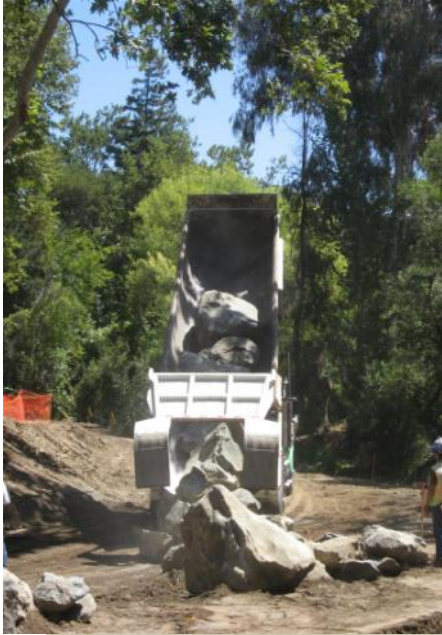
## CHANNEL WIDENING AT HORSESHOE BEND

The new channel centerline was moved well away from the toe of the steep slope below Riviera Road, and away from the sacked concrete and riprap slope armoring. The new channel bed was anchored with a double-stacked row of large boulders weighing more than 1 ton each. New gentler creek bank slopes were created at Horseshoe Bend as planned. The new banks were adjusted and refined in the field to preserve young cottonwood and alder trees that had established on the west bank.

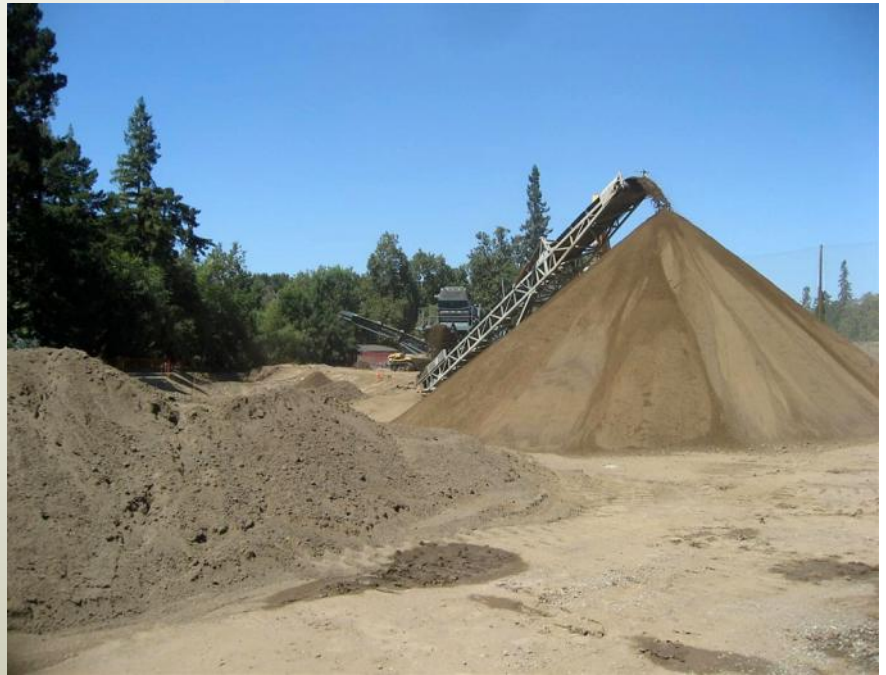
Some areas of the creek banks had been armored with riprap after flood events in the 1990's. Those spots had rock armoring but no vegetation. In those sections the riprap was removed then the banks were graded to a less steep, stable slope and revegetated. The removed riprap totaling

over 800 cubic yards was "recycled" through on-site reuse. It was moved to areas where fill was needed and placed as a base for the fill material, or was used as boulder toe protection along the edge of the new channel.

Fill with particular qualities, known as "engineered fill", was needed to create the new channel and banks. The project designers estimated that more than 1,000 cubic yards of import might be needed to amend the onsite soil to make it suitable for this purpose. Ferma Corporation used specialized equipment during the earthwork process. The equipment sorted, screened and processed the excavated earth to maximize reuse of onsite soil. With use of this equipment, there was no need to import any amendments. The contractor was able to create enough engineered fill using the native soils from the site. In all, over 6,000 cubic yards of existing material was reused on site in the channel restoration process.

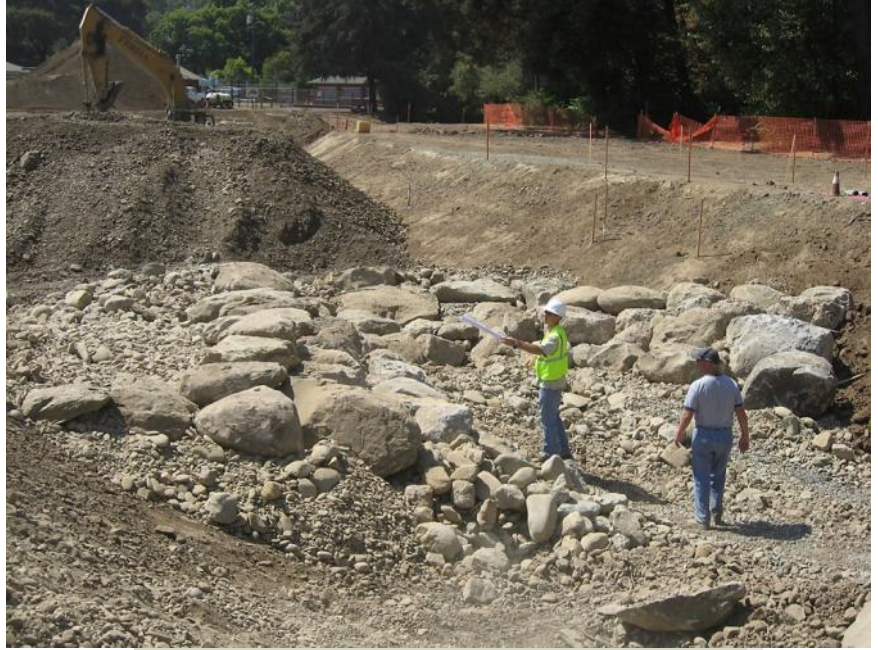
As portions of the channel achieved the proper configuration, stone “cross vanes” were constructed. The cross vanes were created from large boulders weighing 1-1/2 to 2 tons each, placed in a U-shape configuration in a manner that does not require concrete. The cross vanes will maintain the channel bed at the correct elevation and ensure that fish migrating upstream will only need to jump approximately 6”, versus the previous condition of as much as 4 feet at barriers. The reconfiguration created a sequence of pools, glides and riffles in the creek channel to provide healthy habitat for fish and wildlife as well as a healthy, stable creek bed.

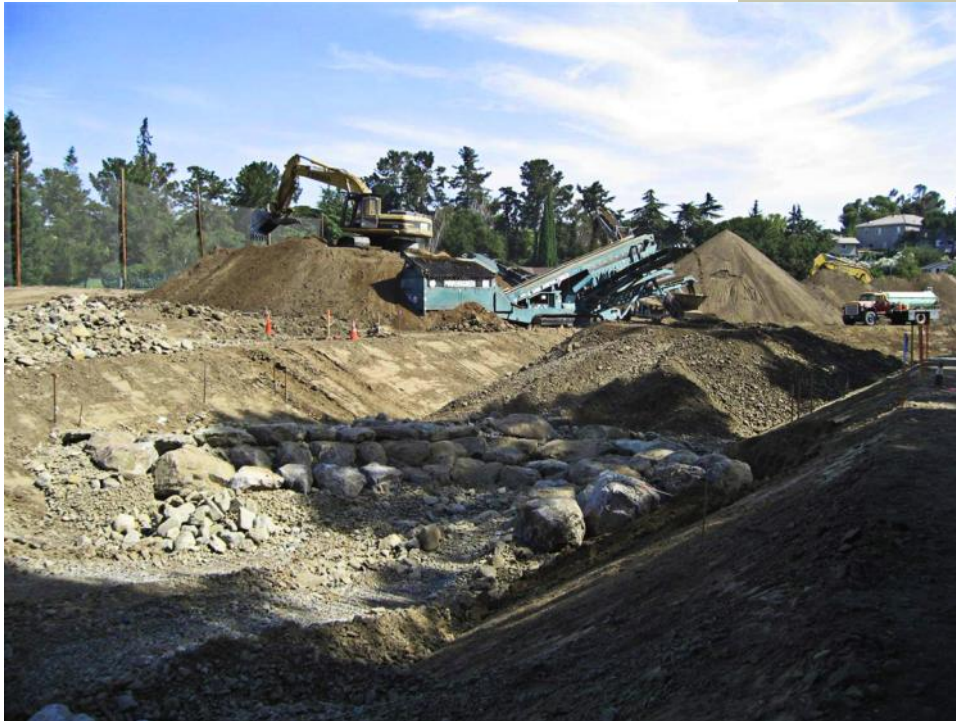
*Here the first cross vane was constructed of boulders weighing as much as 2 tons, placed in a U-shape configuration that stabilizes the channel without use of concrete*

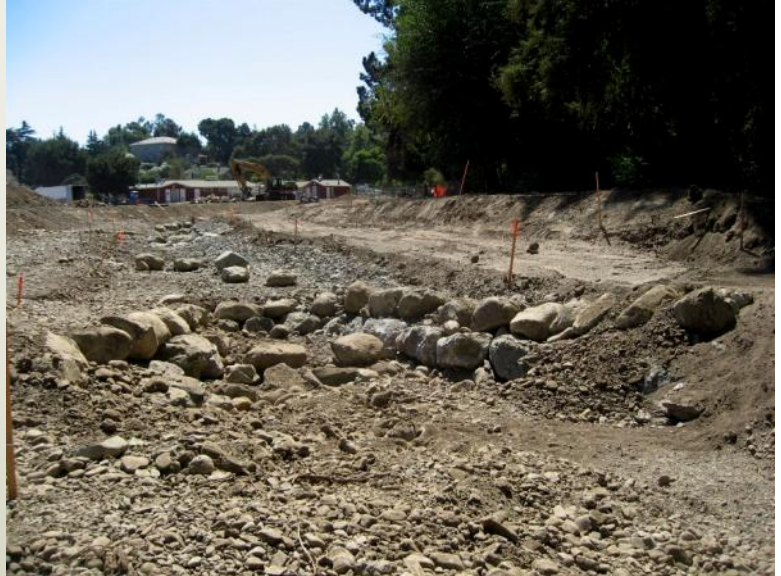
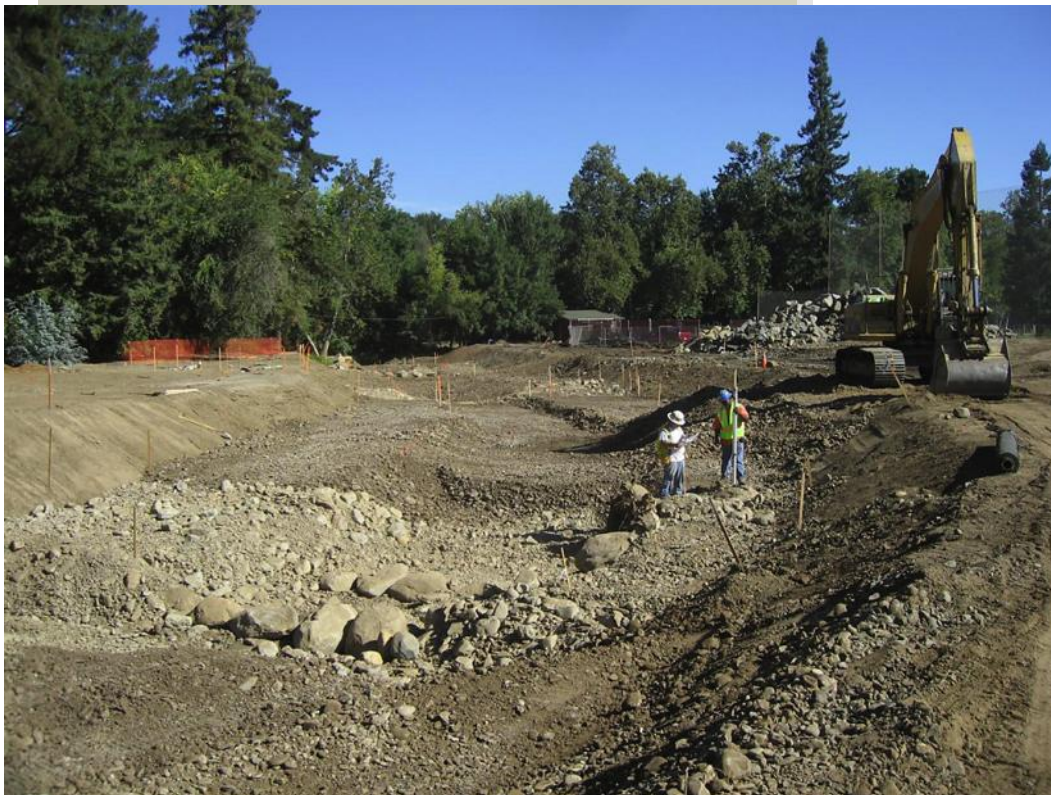
*The new channel through the former parking lot took shape, and the bed was filled with graded gravel and cobble*

Cobbles and gravels of specific size and gradation were needed to line the creek channel. The low flow channel was constructed to the design elevations and the instream “bankfull benches” created. The previously-harvested cobble was replaced in the new channel. Additional channel bed fill was created by sorting out cobble from excavated material when the material contained cobble suitable for steelhead spawning. The benches received a layer of native topsoil and were sculpted to finish grades in preparation for planting. The benches will provide excellent habitat areas and an instream floodplain for high water flows during storms.
