APPENDIX G - ECOLOGICAL RESTORATION AND ENHANCEMENT REPORT

City of Cupertino

STEVENS CREEK TRAIL FEASIBILITY STUDY: ECOLOGICAL RESTORATION AND ENHANCEMENT REPORT

Report Date: July 20, 2002

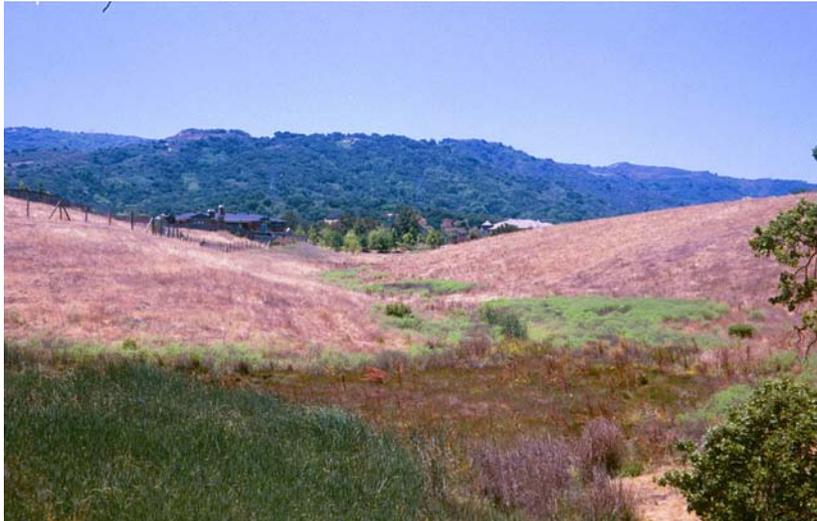
Figure 2—Cristo Rey Drainage looking south

This small drainage is found between Cristo Rey Drive on the north, new homes on the south and two small ridges on the east and west (see Figure 2—Cristo Rey Drainage Looking South). In 1994, red-legged frogs were found in the small freshwater wetland that exists at the bottom of the draw and extends from south to north. Red-legged frogs were also found nearby, on the Lands of the Diocese, in 2000. The Cristo Rey wetland is fed by freshwater seeps and run-off from roads and new houses. Riparian, wetland, and non-native plant species are found in and along the wetland. Blue oak woodland and grassland extend up the slopes on either side of the wetland. An eroding farm road used by hikers and equestrians runs down the west hill and up the east side. The drainage is designated as public open space and is bordered by open space on the northeast and northwest sides. Development surrounds the wetland on the south end. New houses were recently built and others are under construction on the southeast and southwest ends of the draw.

- **Description of Problem**
 - Location—Cristo Rey Drainage
 - Adjacent land uses can degrade the wetland. In particular, new homes are located directly adjacent to the wetland; storm water runoff is directed into this wetland and pollutants from residents' cars and lawn maintenance are likely to degrade the wetland habitat (See Figure 2)

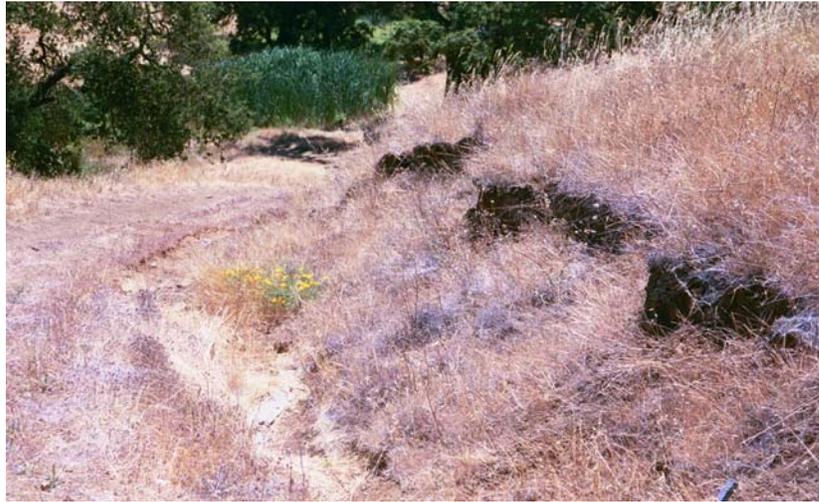
Figure 3—Farm road gully and bank erosion

- Location--along dirt road down the hill on the west side of the wetland
- Gully 2 to 3 feet deep down entire slope and hillside erosion next to the road (Figure 3—Farm Road Gully)
- Soil erodes directly into the wetland below

- Stop erosion
- Fill gully and recontour slope to remove road and eroded slope next to the road
- Redirect trail use to protect the habitat values of the wetland

- Back-fill gully and road cut with native soil that has non-native seeds removed, if possible.
- Cover with biodegradable stabilizing material; seed with a mix of fast-growing, non-invasive grass or other cover species
- Collect local plant material from native annual and perennial plants; have native plant nursery grow seedlings for planting
- Plant with seeds and plugs of native annual and perennial plants

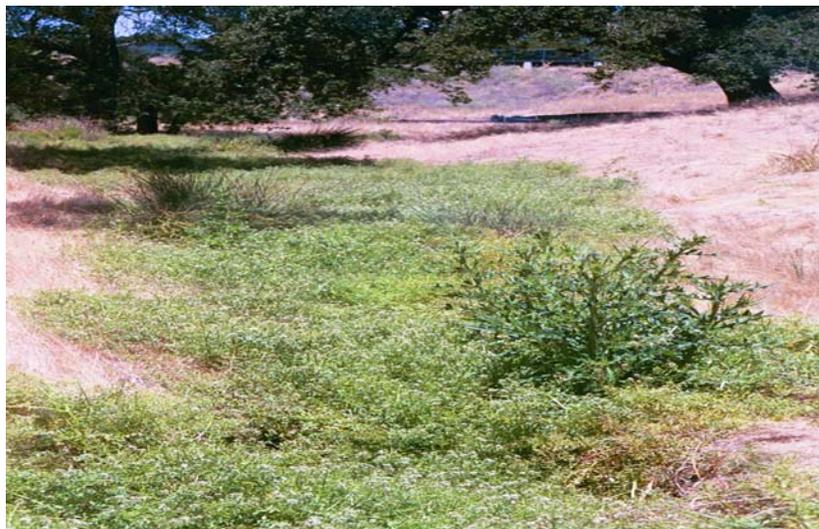
Figure 4—Non-native vegetation clogs the wetland.

- **Description of Problem**
 - Location—along the length of the wetland
 - Non-native wetland species are crowding out native plants (See Figure 4—Non-natives clog the wetland)

- Riparian vegetation cover is missing in some areas
- **Project Goals**
 - Reestablish native wetland species throughout wetland
 - Reestablish riparian species cover, such as willows, where appropriate

- Improve the habitat for red-legged frogs and other wetland/riparian species
- **Potential Methods**
 - Remove non-native species by hand or other effective method as prescribed by restoration experts; use chemical means as a last resort

- Collect local plant material from native wetland and riparian areas; treat and install plant material as recommended by restoration experts
 - Plant with seeds and plugs of native annual and perennial plants

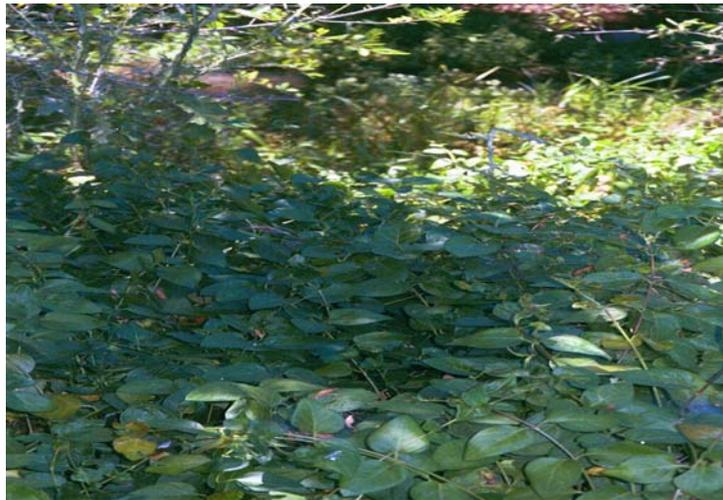
Figure 5—Periwinkle (*Vinca major*) is a common non-native invasive species of the Stevens Creek corridor.

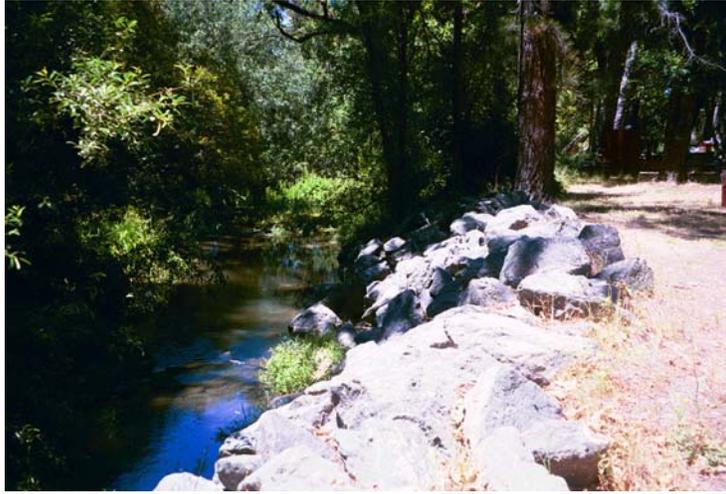
- Location—Rip-rap occurs in Blackberry Farm; creek banks in Blackberry Farm, the Golf Course and Deep Cliff Golf course need resculpting
- Installing rip-rap and compacted soil banks resulted in the loss of riparian species, contributing to high water temperatures and degradation of steelhead habitat

Figure 6—Rip-rap in the Blackberry Farm section of the Creek reduces the stream’s habitat quality

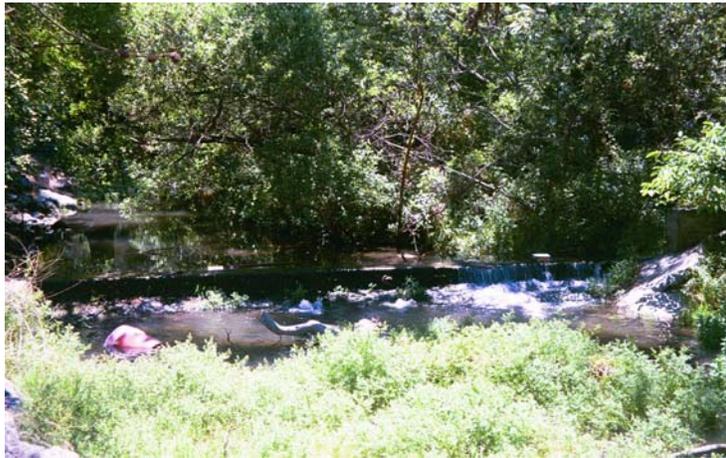
Figure 7—Fish barriers, such as this dam, and low-flow auto crossings can be removed to benefit steelhead trout.

- Prepare creek bed for further fish habitat enhancement
- **Potential Methods**
 - Methods to remove the barriers with the least damage possible to the creek morphology, water quality or vegetation will be determined by a hydrologist, geologist, steelhead expert, and engineer

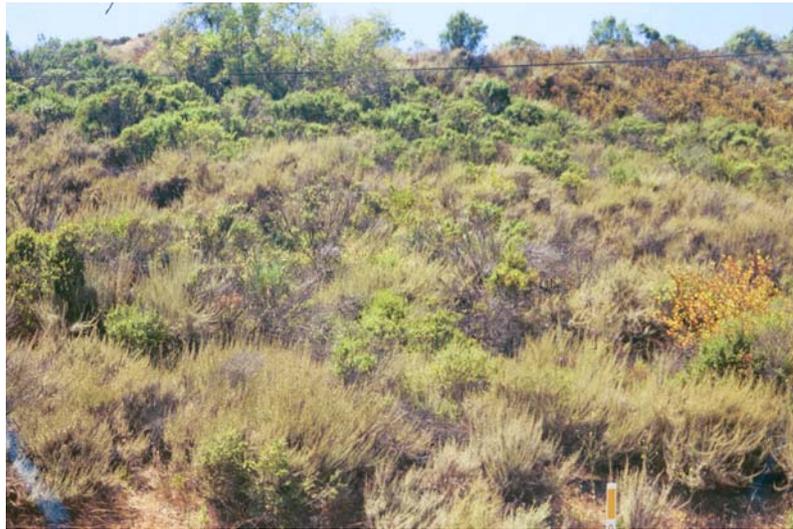
Figure 8—Native chaparral community Stevens Creek County Park

- Freshwater wetland community, which includes potential red-legged frog habitat
- Willow riparian community
- Chaparral and coast live oak woodland (see Figures 8 & 9—Native chaparral/oak woodland)
- Non-native grassland

- Choose species able to survive with minimum maintenance
 - Allow for natural succession of ecological communities
- **Potential Methods**
 - Determine appropriate species mix by looking at reference sites that provide models for the restoration, such as habitat on Stevens Creek County or Linda Vista Parks (Figures 8 & 9)

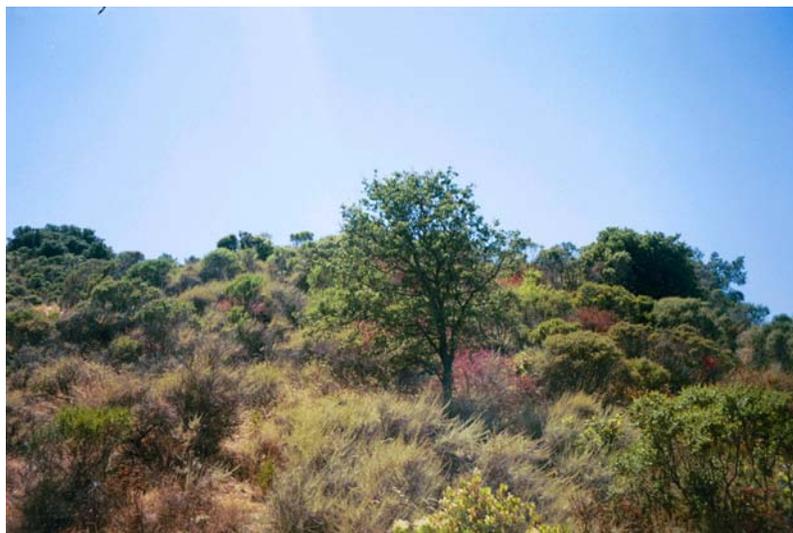
Figure 9—Native chaparral and coast live oak woodland at
Linda Vista Park
